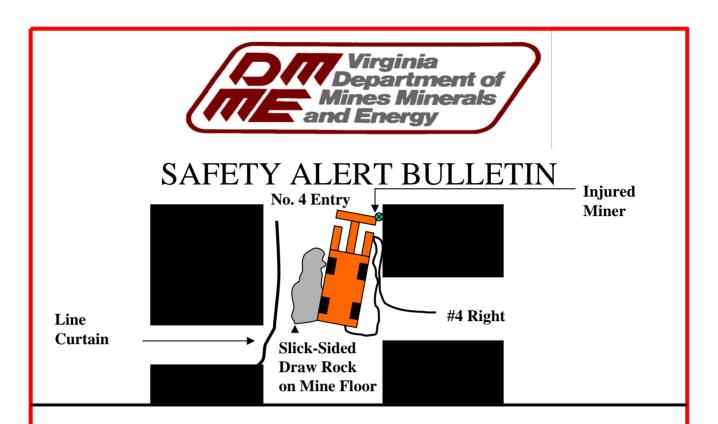
On January 19, 2006, at about 9:00 a.m., a roof bolter operator was injured when the roof bolting machine was being backed out of the working place by another roof bolter operator. The roof bolter machine was trammed upon a slab of slick-sided draw rock on the left side and slid to the right. The victim was attempting to move the machine's cable and was caught between the rib and the right side of the Automated Temporary Roof Support. The injured miner sustained 3 broken ribs on his right side, a fractured right collar bone, a bruised lung, and a fractured sternum.

- 1. No miner shall place himself or be placed in a pinch point between equipment and a rib or face.
- 2. Haulage roads shall be maintained reasonably free of bottom irregularities, excess spillage, debris, wet or muddy conditions that make controlling equipment difficult.
